# Manhole Inspection Summary

Manhole # S41WW\_014MH

**Location** Address: **3220 LOCH RAVEN BLVD** Cross Street: **GORSUCH AVE**

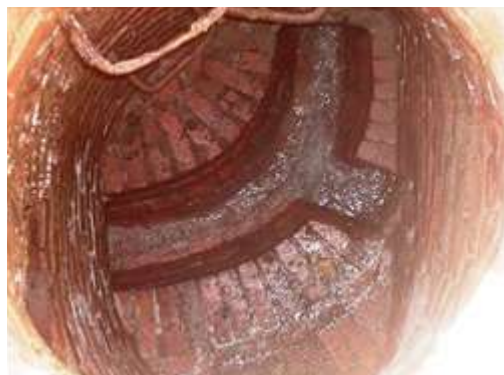
Top View

Corroded steps. Bench debris.

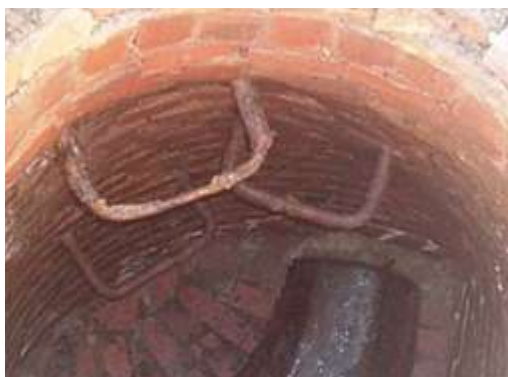
Defect

Corroded steps.

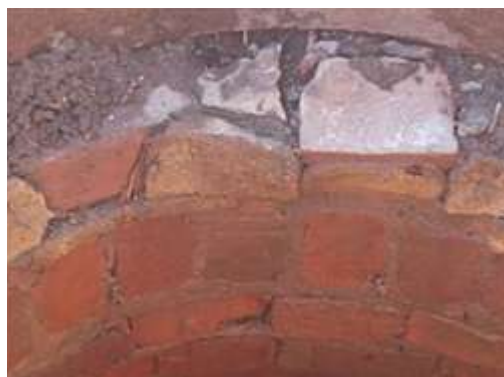
Defect

**Frame** Offset: **3** (in.) Condition: ☐ Sound ☐ Cracked ☒ **Leaks**

**Chimney / Frame Adjustment** ☒ Exists Material: **Brick** ☐ Parged Height: **3** (in.)  
Condition: ☐ Sound ☐ Cracked ☐ Root Intrusion ☒ **Loose Brick** ☒ **Deteriorated**  
Infiltration: ☐ None ☒ **Joint** ☐ Cracks ☐ Mortar ☐ Roots ☒ **Wall**

Frame leaks. Frame offset. Adjustment deterioration, loose brick and infiltration.

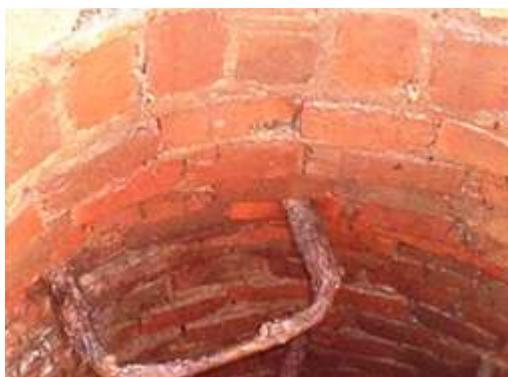
Defect

**Corbel** Material: **Brick** ☐ Parged Type: **Concentric/Eccentric**  
Condition: ☐ Sound ☐ Cracked ☐ Root Intrusion ☐ Loose Brick ☒ **Deteriorated**  
Infiltration: ☐ None ☐ Joint ☐ Cracks ☒ **Mortar** ☐ Roots ☒ **Wall**

Adjustment and Corbel deterioration and infiltration.

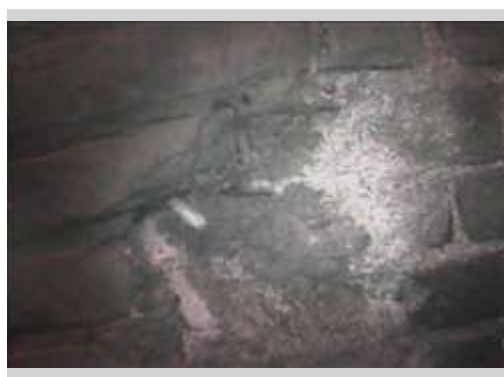
Defect

**Barrel** Material: **Brick** ☐ Parged  
Shape: **Circular** Diameter: **46** (in.) Length: (in.)  
Condition: ☐ Sound ☐ Cracked ☐ Root Intrusion ☐ Loose Brick ☒ **Deteriorated**  
Infiltration: ☐ None ☐ Joint ☐ Cracks ☒ **Mortar** ☐ Roots ☒ **Wall**

Barrel deterioration and infiltration.

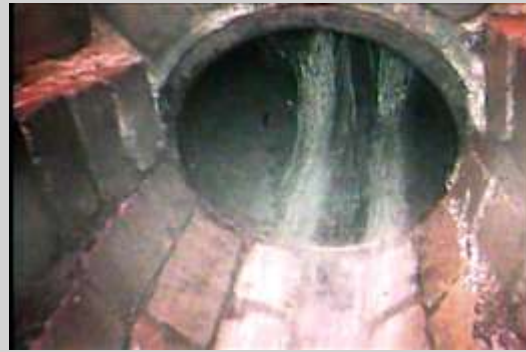
Drop In @ 8 O'Clock

Channel deterioration.
